## **Inspection Report**

**3132 E. Wood Drive  
Maple Grove, MN 55311  
Prepared for: Larry Mayor**

**REPORT #:** Sample Report.  
**DATE OF INSPECTION:** October 26, 2006.  
**TIME OF INSPECTION:** 5:00 pm.  
**CLIENT NAME:** Larry Mayor.  
**MAILING ADDRESS:** 1314 Ridge Road, Marshfield, WI 55449.  
**CLIENT PHONE #:** 715-389-8129.  
**CLIENT FAX #:** 715-389-3881.  
**INSPECTION SITE:** 3132 E. Wood Drive, Maple Grove, MN 55311.

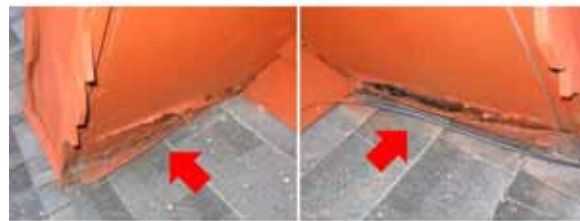
Loose roof flashing - Gabel corners

Loose flashing noted, The potential for water entry is present, Repairs / sealing recommended.

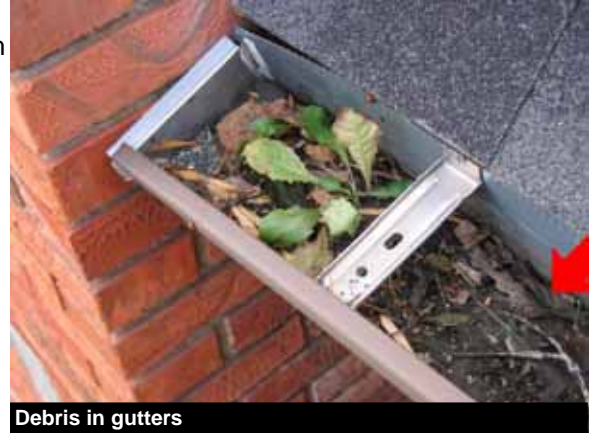
Appears satisfactory and serviceable - gutter system was not tested, Loose gutter downspout strap noted - SW corner, Debris in gutter - recommend keeping clean.

Debris in gutters

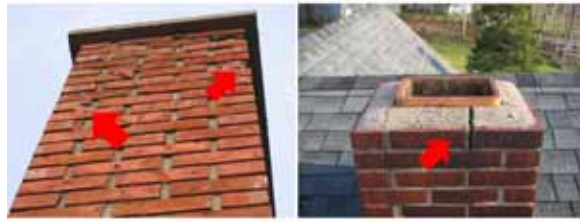
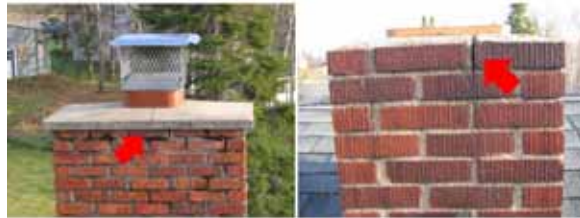
**Cracked Caps and Flacking brick**

Chimneys appear satisfactory and serviceable, Limited visibility, Cracked chimney caps noted (minor) - monitor for repairs, Minor flaking and spalling brick noted on upper portion of the fireplace chimney - monitor. Recommend point tucking masonry repairs to both chimneys as required.

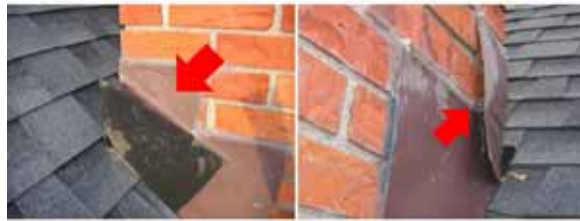
**Loose chimney flashing**

Flashing material: Metal, Asphalt, Flashings appear satisfactory and serviceable, Fireplace chimney flashing is pulled away from chimney. An annual evaluation / sealing of the chimney flashings is recommended.

It is recommended that a chimney that is greater than 30 inches wide, should have a cricket flashing installed. Such is recommended in the future when the roof covering materials are replaced. Note: A cricket flashing is a small peaked roof, perpendicular to the main roof slope and as wide as the chimney, that is constructed at the high side of the chimney to divert water around the chimney.

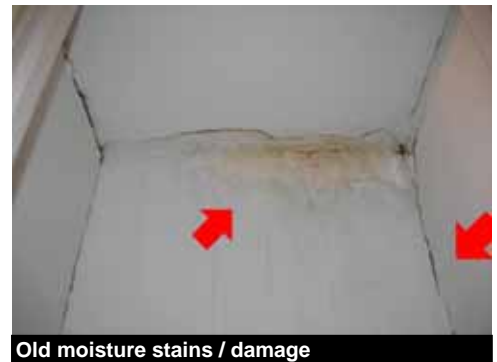
Old moisture stains / damage noted, LOCATION: Upper level-wall closet ceiling.

Old moisture stains / damage

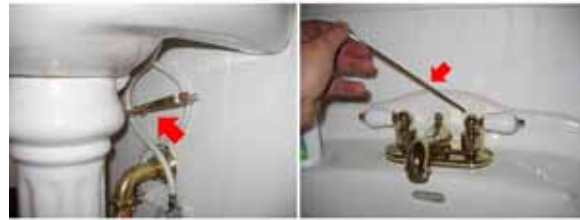
Inoperative vanity sink stopper

Appears satisfactory and serviceable. The following problems were noted at the drain: Sink drain stopper operator mechanism is inoperative - repairs required.

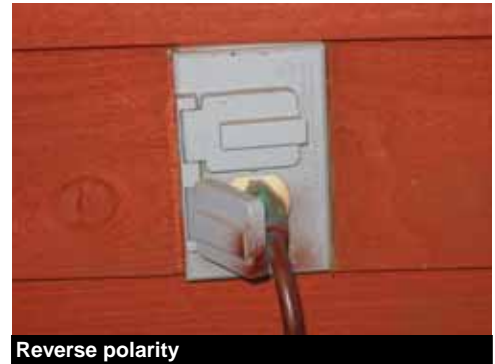
**REVERSE POLARITY CONDITION PRESENT:**

east exterior wall electrical outlet.

Various electrical outlets tested with reversed polarity and open ground conditions throughout many of the rooms on all three levels of the house. Recommend that a licensed Electrician evaluate and make necessary repairs to all improperly wired interior and exterior outlets in the house and garage. This type of service is typically the responsibility of the home buyer.

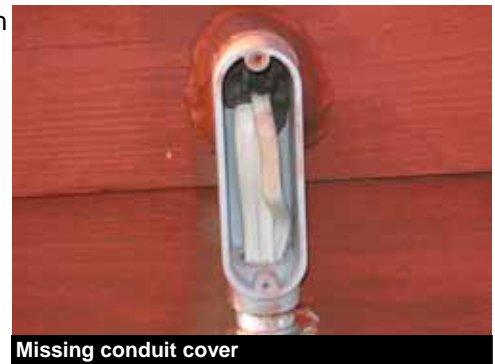
Missing cover on conduit LB (south side of the house)

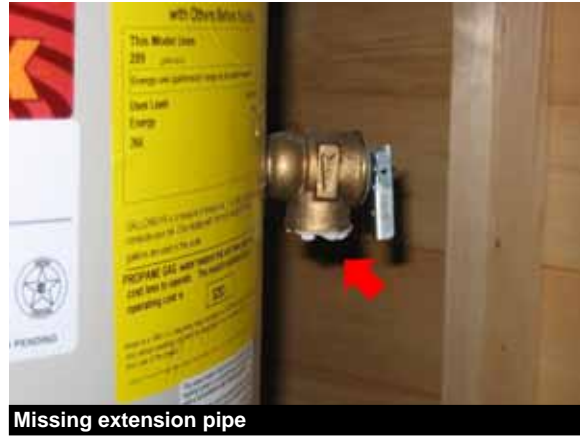
**Missing extension pipe**

Relief valve noted. Appears satisfactory and serviceable - not tested, Signs of past leakage noted, Hot water heater temperature / pressure relief valve extension piping was missing - (extension piping needs to terminate approximately 6"-12" off of the floor) - Safety Concern.

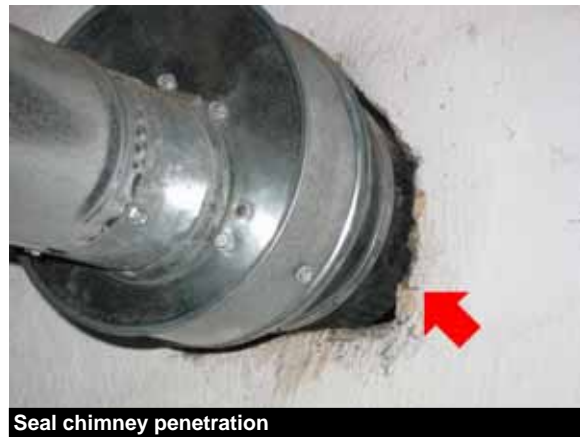
**Seal chimney penetration**

Flue vent is intact. Appears satisfactory and serviceable, Recommend sealing vent piping at chimney penetration.

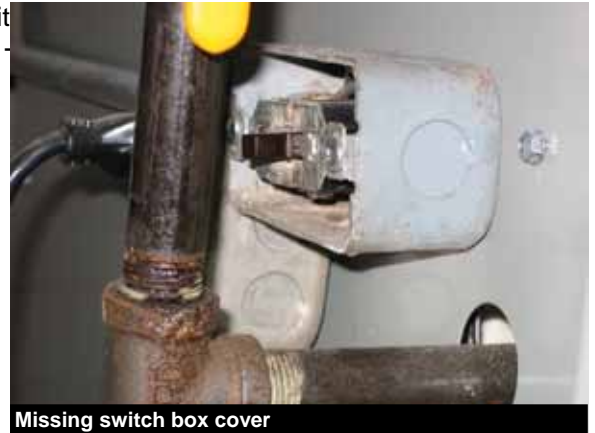
Electrical disconnect at unit noted, Missing cover plate - Safety Concern.

Missing switch box cover

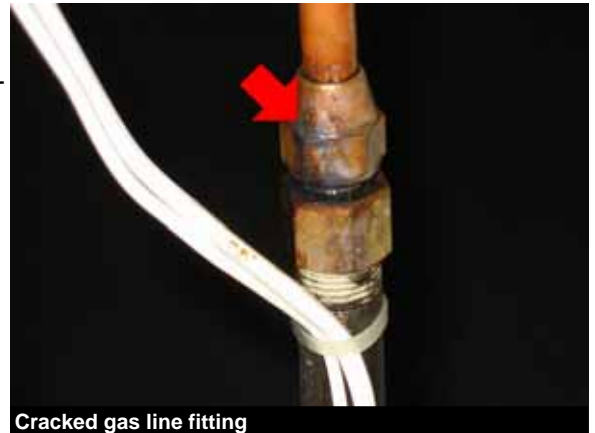
Furnace gas line flare fitting is cracked and is leaking - repairs required - **Safety Concern.**

Cracked gas line fitting

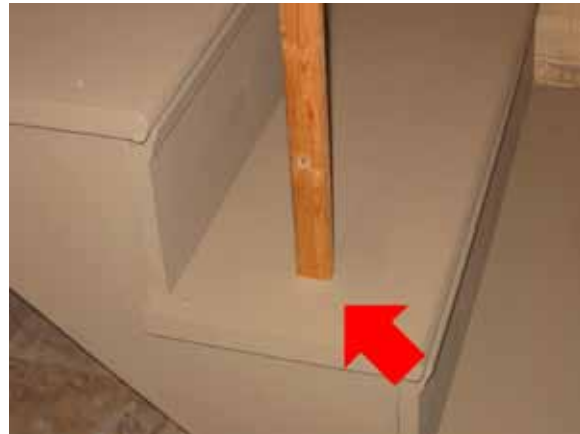
Basement right hand stair handrail loose at base - recommend repairs - Safety Concern.

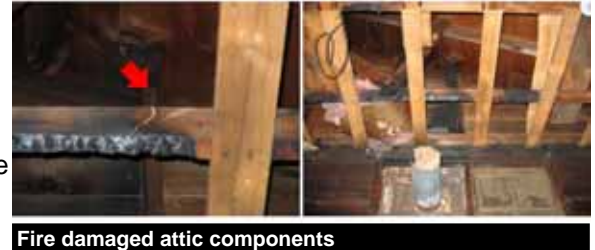
Appears satisfactory,  
Limited / Partial visibility,  
Fire damage to the attic  
structure was noted.  
Damage appears to have  
been cause by an over-  
heated wood burning stove  
at sometime in the past.  
Recommend repairs to a  
cracked ceiling joist in the  
fire damaged area.

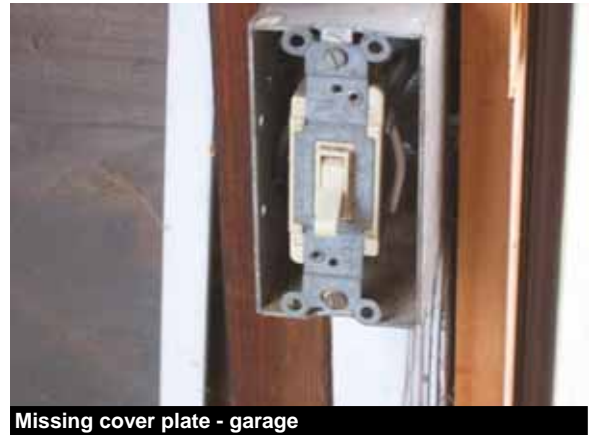
**SWITCHES:** Appear satisfactory and serviceable unless otherwise noted, Missing cover plate noted - west wall.
